Double-Diameter Upsizing With Pipe Reaming

Salina, KS, a city known as “The Best Place In Kansas To Raise Your Kids,” is in part managed by Utility Services personnel tasked with guarding the city treasury to help continue this style of community life. That led to the city exploring the various replacement methods and procedures to replace an aging 12-inch, vitrified clay pipe (VCP) gravity sewer with a 24-inch pipe line for needed increased capacity.

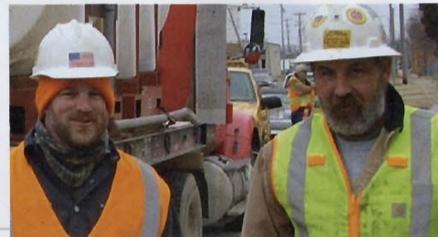
Top left: Unusual but effective drill location.
Top right: Insertion pit.
Above: Jeremy Wills, driller (left) and Jim Heiman,
Left: Steve Palmer, utilities engineer.
